## Confidential Inspection Report 4121 NE Alameda St Portland OR 97212

December 6, 2014

A visual inspection of the above referenced property was conducted on 12/04/14. An earnest effort was made on your behalf to discover all visible defects. The following is an opinion report, reflecting the visual conditions of the property at the time of the inspection only. Hidden or concealed defects cannot be included in this report. No warranty is either expressed or implied. This report is not an insurance policy, nor a warranty service.

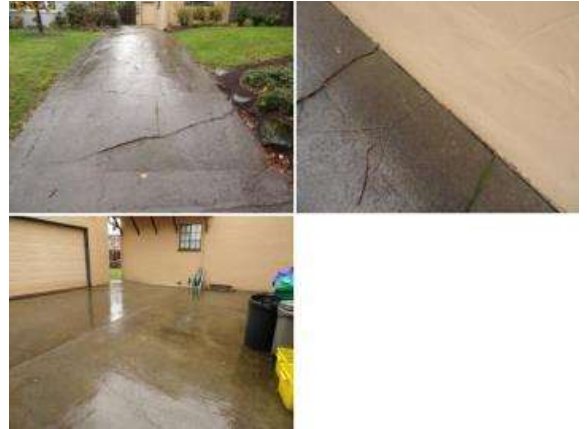
Minor cracks are noted. Consider future repairs. Suggest sealing all cracks along foundation to prevent potential water penetration into basement.

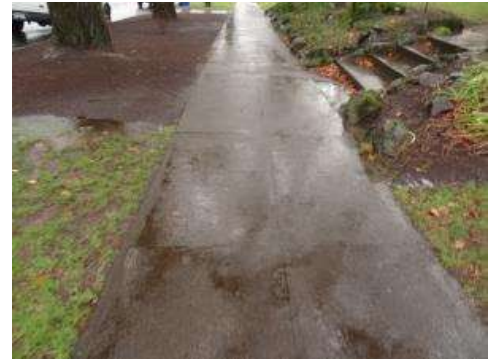
Concrete. Appears serviceable Typical cracks are noted.

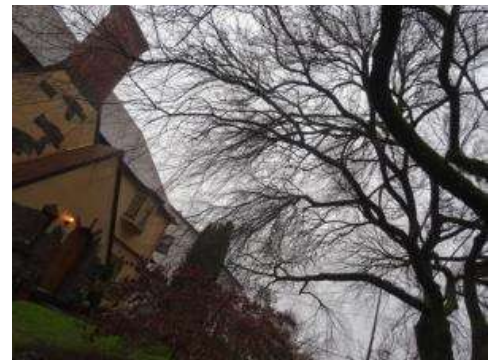
Maintained Maintain at least one to two feet of clearance between building and plants. Monitor large trees for dead branches. Pruning is recommended.

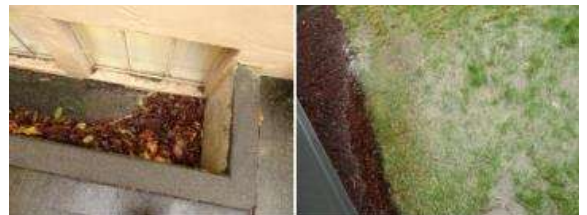
Flat Site Ensure window wells are maintained clear of debris. Suggest potentially improving drainage in backyard. Pooling water is noted.

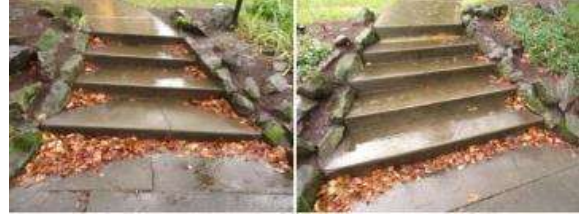
Handrails are missing.  
Minor age related  
deterioration is noted.

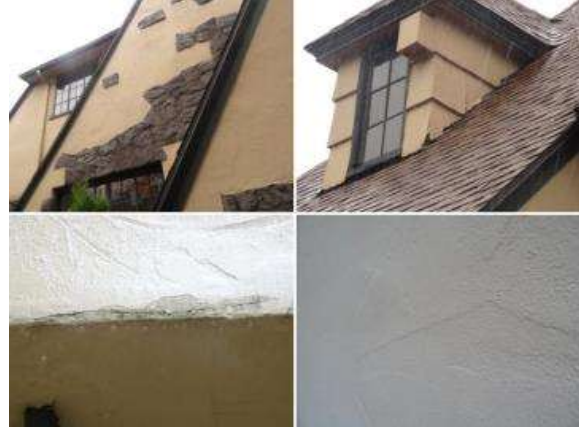
Minor damage is noted at cedar shingles. Suggest providing proper clearance between siding and roof at rake walls to prevent wicking of water into siding causing damage. Consider repairs and improvements.

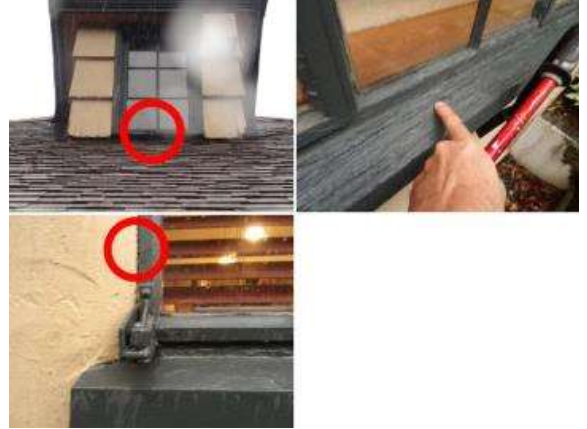
Early signs of moisture related damage are noted at window sill mostly on south side of building. Sills will need to be repaired and properly prepped for painting. Ensure all trim is properly painted and caulked to prevent water related damage in the future. Maintain Trim in well painted and caulked condition. (Check all doors and windows for damaged caulking) Ensure annual inspections are conducted and touch up, caulking and repairs are completed as needed.

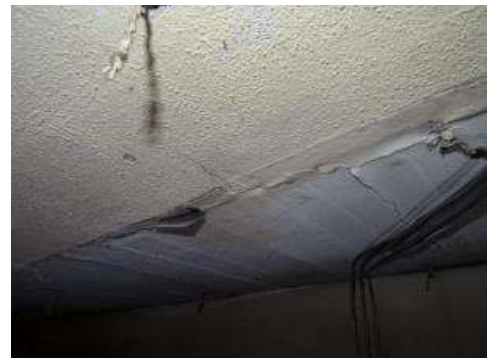
Subfloor is not visible due to fixed ceilings. No staining indicating issues is noted. Asbestos is noted in some areas of the ceiling. Suggest removing or sealing.

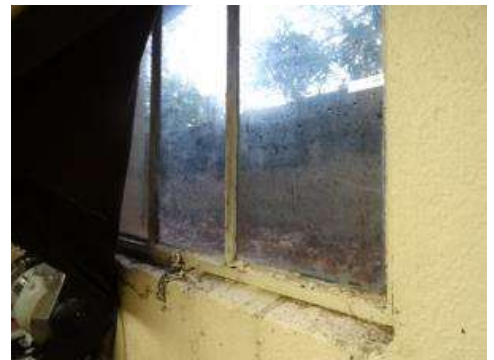
Wear is noted. The windows as installed are not egress accessible. As a result of the lack of egress, the areas should not be considered as living space nor used as a sleeping area for safety reasons.

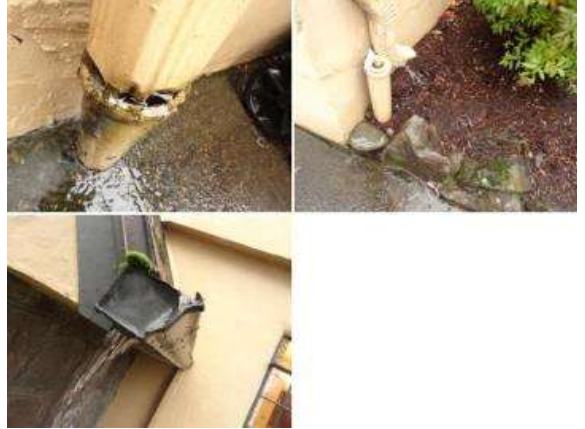
**GUTTERS AND DOWNSPOUTS:** Full gutters system is installed  
 Subsurface drains are clogged. Corrections are needed.  
 Ensure gutters are maintained clear of debris. Improper drainage of gutters is responsible for 90% of all basement and lower level moisture issues in homes.  
 Extend down spouts away from building.

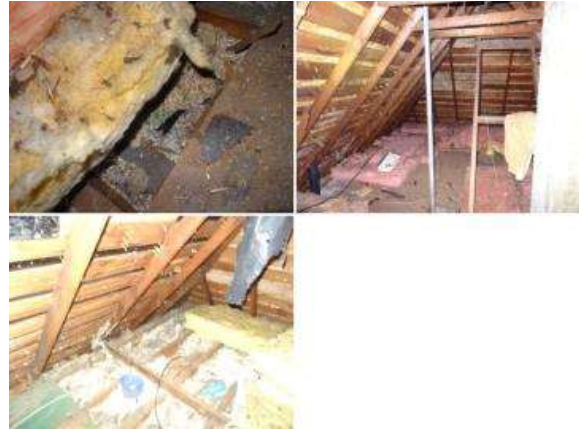
Minor damage is noted at a rafter on west side at dormer. (Improper cut)

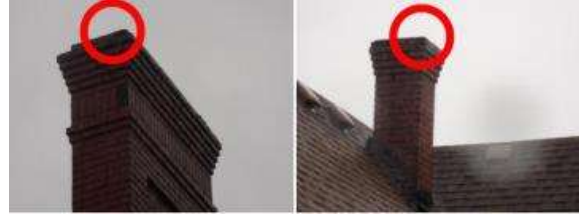
It appears that both chimneys are in need of a proper crown. **Improvements are recommended.**

Improvements are recommended.

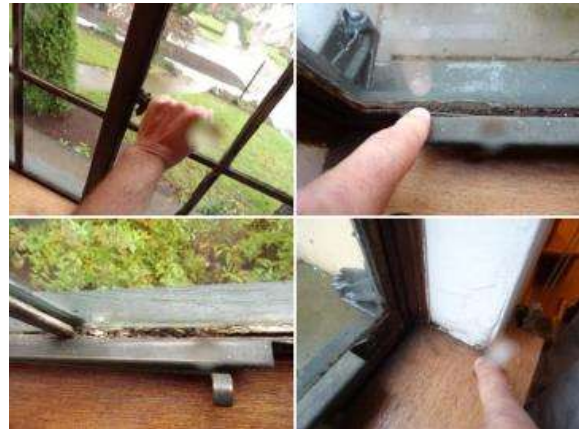
Metal/Aluminum  
Damage is noted. Some windows can not be opened. Windows need to be further evaluated to see if they can be repaired or if they need to be replaced.  
Moisture is penetrating at windows in some areas.  
Corrections are needed.

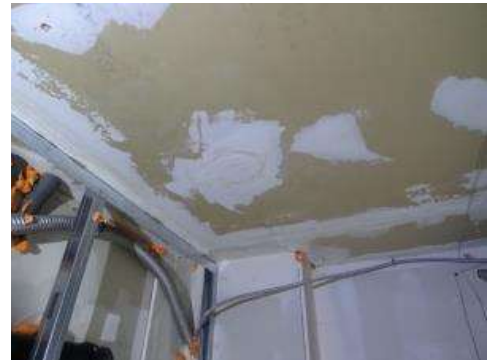
Plaster Dry wall. Minor staining is noted in garage. Staining is related to shower pan leak above and does not appear to be active at this time. Suggest asking home owner about shower pan condition and possible repairs having been completed.

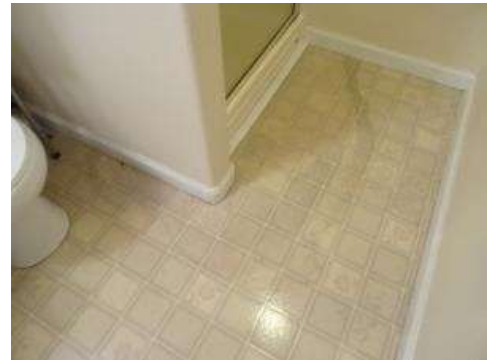
Wood, Carpet, Pergo Type Floors and Vinyl Appear serviceable Staining is noted in ADU bathroom indicating potential leak at shower pan.

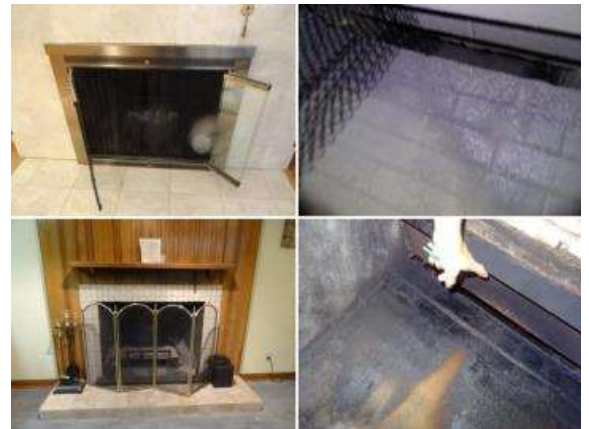
Living room, Basement. Masonry systems appear to be in serviceable condition with both dampers being operational. Some dirt appears to prevent full operation of dampers. Recommend cleaning system including chimney before use.

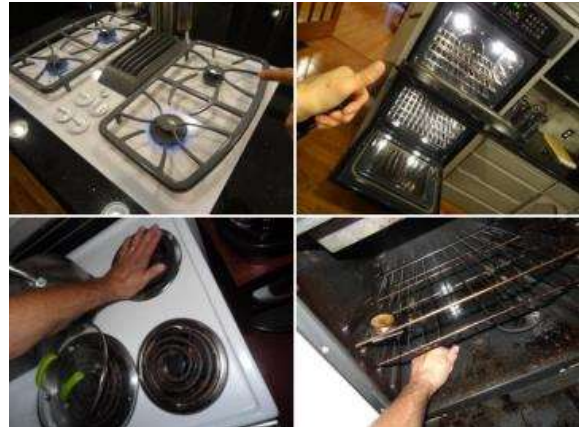
Gas, Cook Top in main kitchen is operational with right side back burner needing adjustments in order to function properly.  
Oven is operational  
ADO is electric. Back right side burner is not operational.  
Oven element in bottom is not operational.

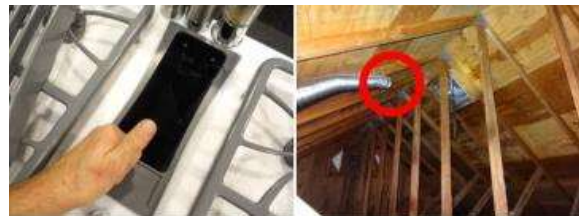
Exterior in main kitchen. Vent controls in ADU are not located. Further information is needed.  
ADU vent terminates into attic. Corrections are needed.

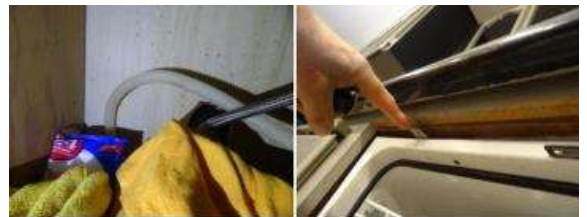
A high loop or air gap is not installed. Corrections are needed  
Dishwasher needs to be attached to counters properly to prevent falling forward.

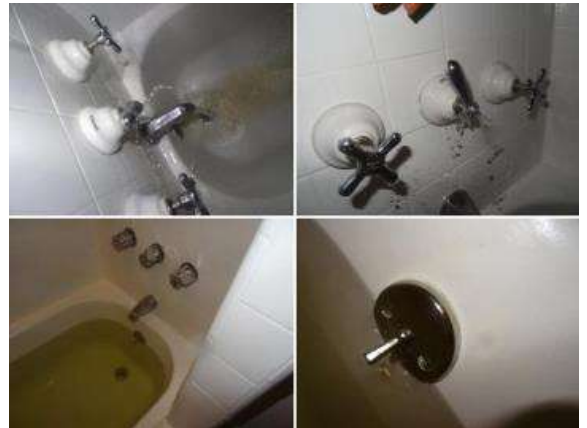
Improvements are needed at upstairs bathroom fixtures. Shower faucet handle control is leaking in J&J bathroom. Repairs are needed. Slow drain is noted in master bathroom. Overflow is leaking into walls causing water to drain into ceiling of entry area and subsequently into basement. Repairs are needed.

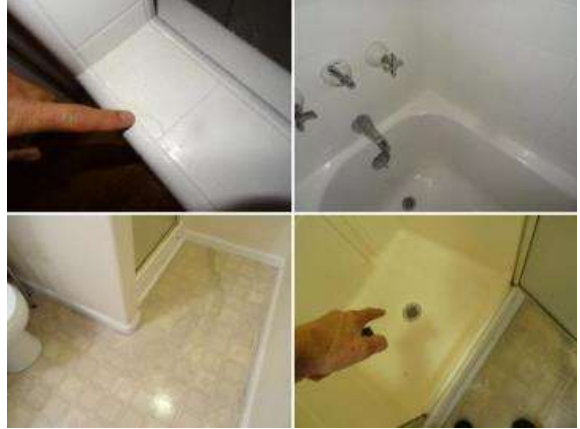
Pan of ADU shower has had or may have an active leak. **Staining on floor indicates moisture.** Non was noted today but leak may only be active when someone is actually in the shower. (Flexing pan causing leak)  
**Further evaluation is recommended.** Suspect damage to sub floor of bathroom. (Swelling)

Further evaluation is recommended. Suspect damage to sub floor of bathroom. (Swelling)

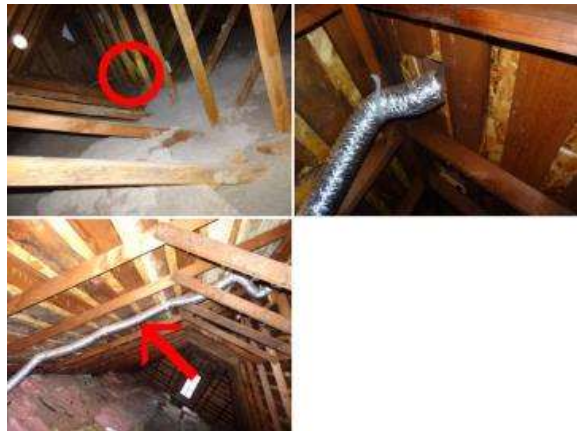
Bathroom vents inside main building are ducted to roof. Runs are too long and moisture will condensate inside ducts eventually draining back into fans where mold will grow. Suggest improvements.

Suggest improvements.

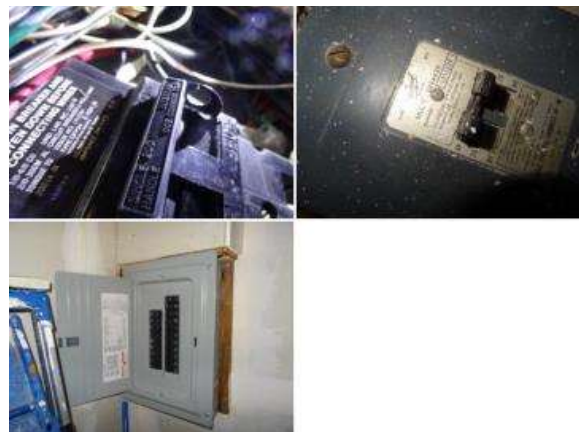
Basement and garage. Panels are labeled in both locations.  
 Main inside the home is 200 amp  
 Secondary main in garage is 100 amp.  
 A small sub panel made by Federal Pacific is installed directly next to main. Panel hold a single 220 breaker. Federal Pacific breakers are known to malfunction and we generally recommend having these panels replaced. Suggest improvements. (Minor)

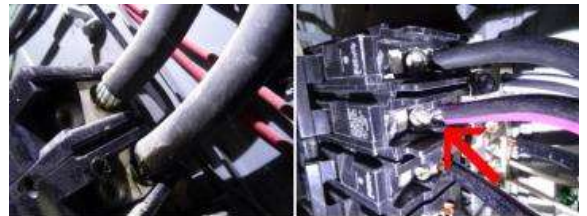
Garage main wiring is in need of some anti oxidant  
Minor corrections are needed Both main wires are Aluminum.

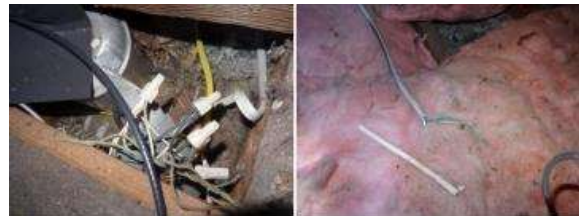
Copper  
Improper conditions are noted in attic. Corrections are needed. Open and or missing Junction Boxes are noted. (2) Abandoned wiring is noted. (2) Terminate wiring properly.

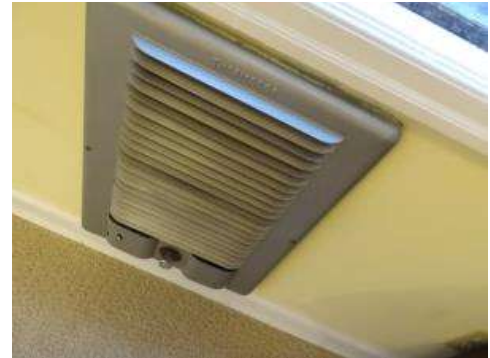
Space heaters are considered a fire hazard and should not be installed where contact with combustibles is possible. Many of them have been recalled due to safety related issues. I recommend considering a safer more efficient type of heat such as ceramic flat panel heaters or oil filled radiant heat units. Improvements are suggested.

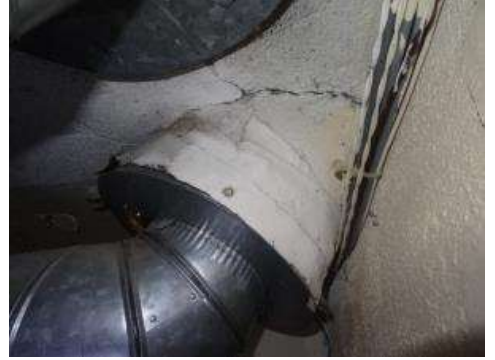
Proper air flow is noted throughout the building. Recommend Cleaning Ducts. Asbestos tape is noted at ducts. Consider sealing tape by painting or wrapping in new tape to prevent any future deterioration. Or remove entirely.

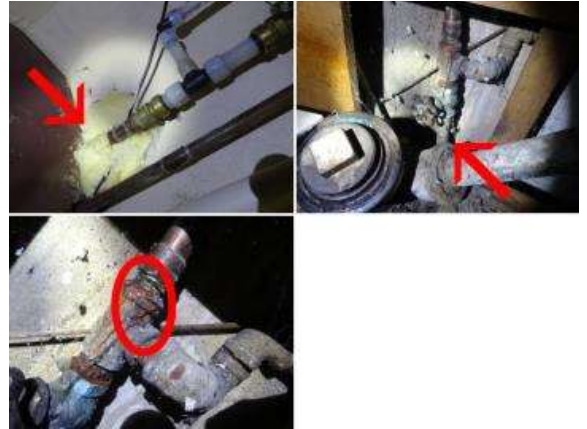
While it appears that a new line had been installed, checking for main indicates that the material is galvanized. Lines are however somewhat hidden and the new line may not actually be visible. A minor leak is noted at a connection directly above galvanized material. Repairs are needed.

Suggest further evaluation and inquiry with home owner about the document stating that line had been replaced.

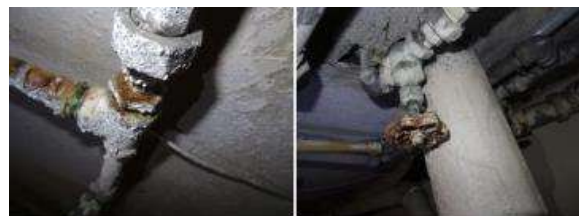
Corrosion and other age related issues are noted at galvanized lines. Leaks are noted and need to be repaired. Consider upgrading the system to modern WIRSBO in the near future.
