Confidential Inspection Report 01837 SW Radcliffe RD Portland OR 97219

December 27, 2014

RE: 01837 SW Radcliffe Rd Portland OR 97219

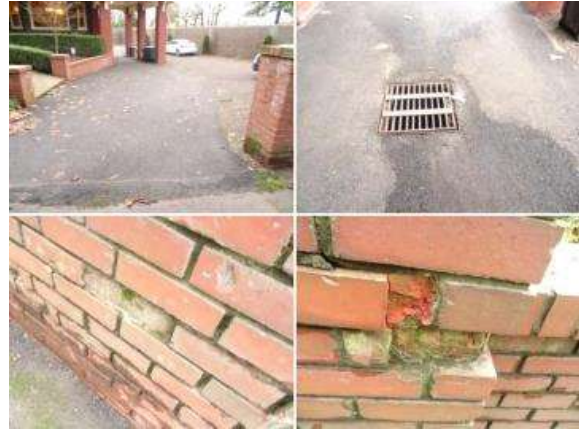
Appears serviceable
Drainage is noted and appears to be in serviceable condition.
Walls between driveway and sidewalks are damaged and deteriorating. Consider future improvements.

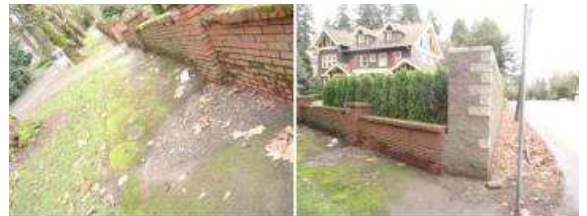
Sidewalks

Concrete and paved.
Deterioration is noted. Repairs are suggested to prevent trip hazards and ultimately reduce liability issues
Corrections are recommend.

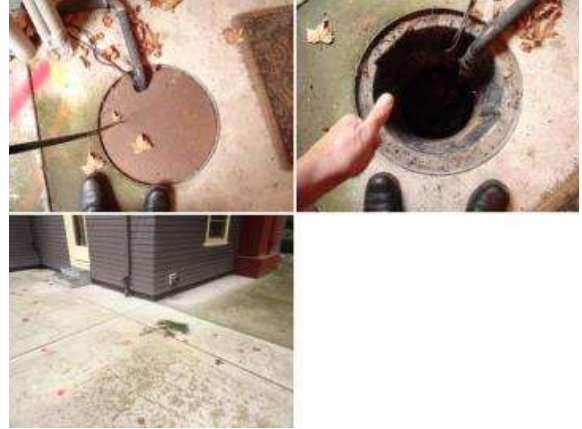
Flat Site
 Drainage is serviceable.
 Grade at foundation is satisfactory
 Water appears to be draining away from building properly.
 North sided basement access staircase allows for water to drain down stairs. A sump pump is installed at the bottom of the stairs. Pump was operated today and found to be in good working order
 Check on this pump annually before the wet season starts.

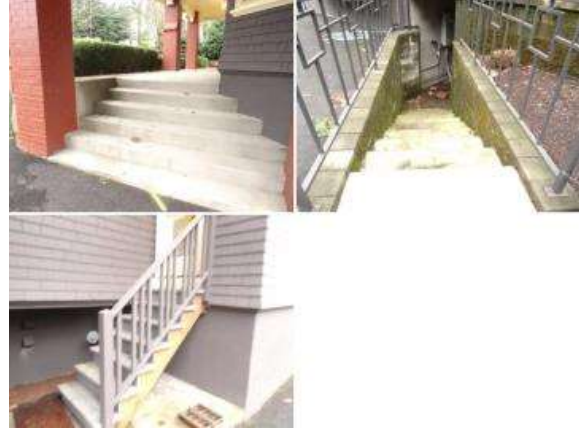
Exterior Stairs/Stoops

Handrails are missing.
Side access stairs are in good condition.
Maintain all paint at side stairs in good condition.
Check for damage every year and make improvements as needed.

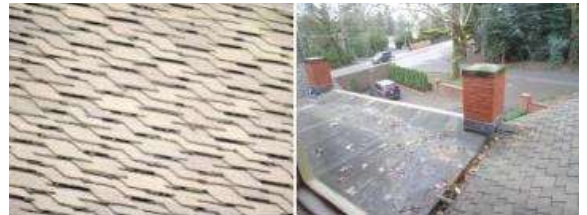
Satisfactory - The roof covering material is in a condition that is consistent with its age and method of installation, showing no deficiency or cause for immediate concern.

Minor signs of moss are noted. Recommend regular service to maintain roof clean and in good condition.

Consider future improvements by replacing all flat roofing material with TPO liner type sheet goods.

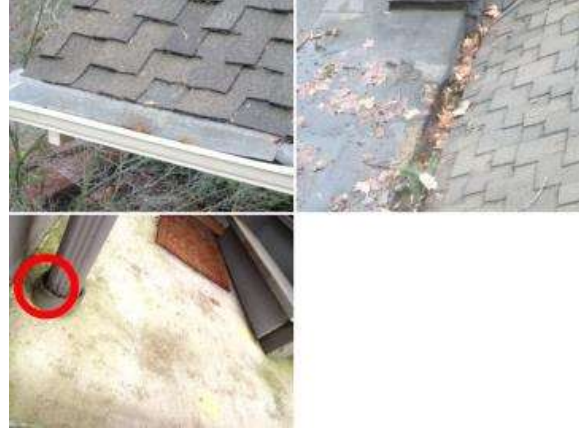
GUTTERS AND DOWNSPOUTS: Full gutters system is installed. Appears serviceable. Subsurface drains are noted. Subsurface drains are not part of this home inspection. I recommend monitoring the drains for clogging. Debris is noted in drain system above front porch. Corrections are needed. Ensure gutters are maintained clear of debris. Improper drainage of gutters is responsible for 90% of all basement and lower level moisture issues in homes. Screens are partially installed on gutters. Recommend removing and continued cleaning of the system. Suspect clogged subsurface drain on east side near side stairs. Monitor and make repairs as needed.

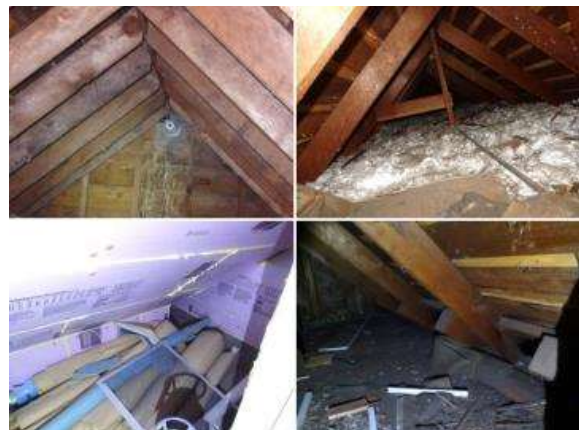
Partial Attic areas are noted and accessed. Conventional Framing. Framing is in good condition. Several attic areas are completely insulated. Consider additional insulation in main upper attic area. Additional ventilation is recommended. Consider installing solar powered mechanical

venting.
This type of vent will run every day rain or shine and promote proper ventilation at all times. In addition it will lower temperatures in living areas during summer months by ten to fifteen degrees.

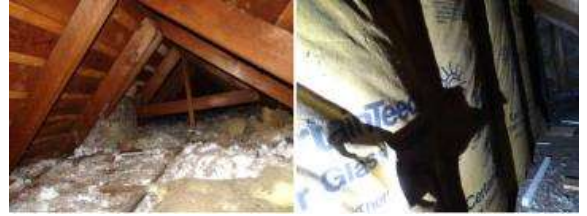
Fiberglass Bats and Fiberglass Blown In In Floor and in walls. Insulation is compacted, the true R Value can not be established Consider adding insulation.

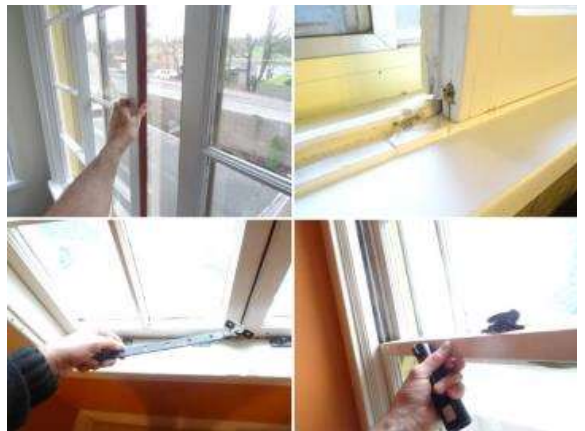
Wood with aluminum storm windows. (Old) New windows are wood. Ensure these windows are maintained in well painted condition as this type of lumber deteriorate rather fast if neglected Damage is noted. Sash cords are missing. Damaged hardware is noted.

Windows as a group are generally serviceable. Make minor improvements as needed.

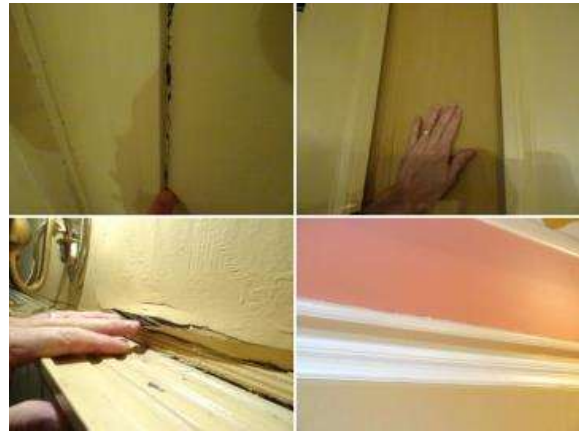
Wood wainscoting, old wall paper, plaster and dry wall. Appears to be serviceable. Cracks are noted in alder walls. Mostly in dining room area on south side of building. (Not an indication of any structural issues)

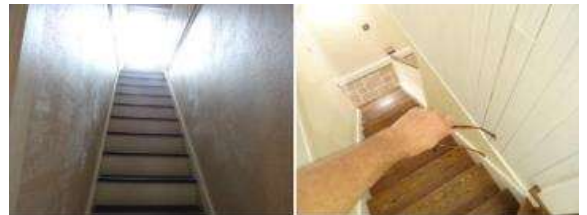
Handrail is missing. Corrections are recommended.

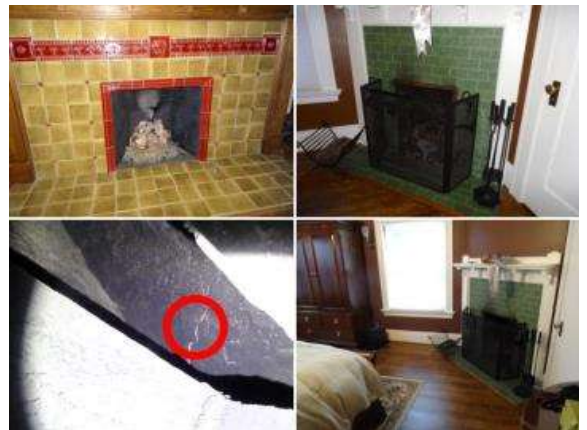
Living room, Bedroom. Living room system is in operational condition. Damper is not installed. Gas system. Bedroom system has minor damage in flue. Suggest repairs. Damper is missing. Corrections are recommended. Free standing system is installed in upper level.

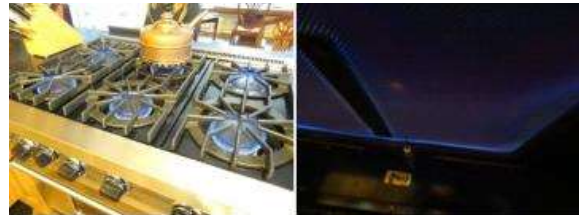
Range/Cook Top And Oven

Gas
Free standing
Appears to be serviceable
Damage is noted.

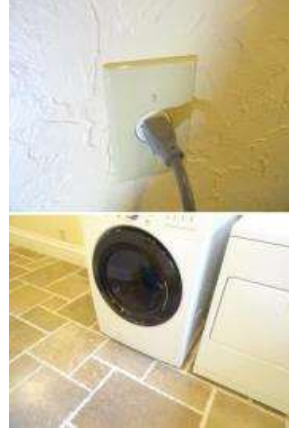
110 is grounded. GFCI protected outlet is suggested at washing machine outlet.
220 is provided. Vent is provided. Recommend installing ridged metal vent for safety
Recommend installing pan under washing machine with plumbing draining to safe location at exterior of building or into plumbing drain. (Insure a trap is installed if plumbed into drain)

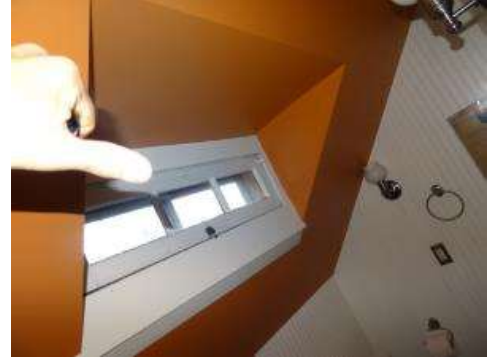
Bathroom on third floor is without proper ventilation. Consider corrections.

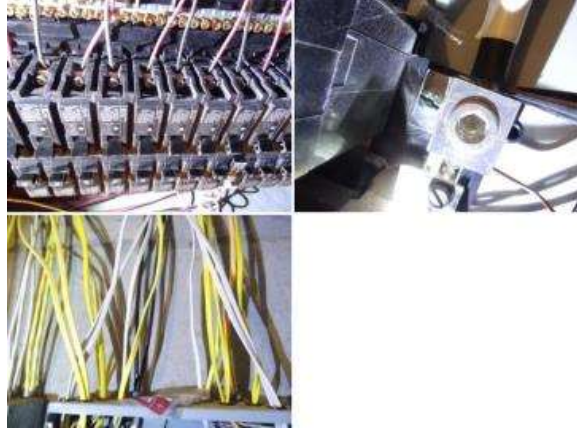
Circuit and wire sizing correct so far a visible. Grounding system is noted and appears to be serviceable. Bond is noted. Wiring above panel is unprotected. Corrections are recommended.

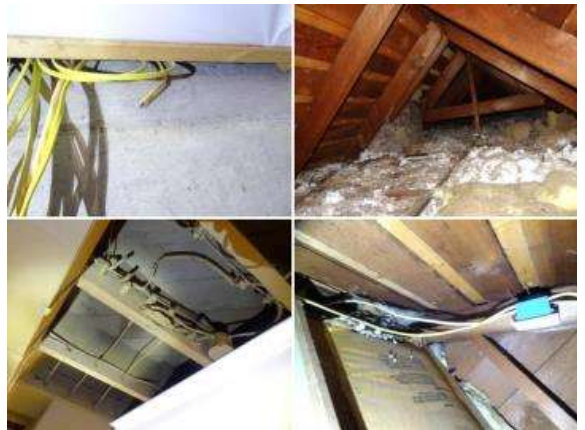
Copper
Wiring appears to be in serviceable condition. Improperly terminated wire is noted above panel. Minor corrections are recommended.
Knob and Tube wiring is noted in basement and is suspected throughout the building inside walls. Suspect K&T wiring under insulation in attic. K&T wiring can not be covered by insulation. Suggest asking home owner about the presence of this type of wiring in attic and if it had possibly been removed. If still installed, corrections will be needed.
Consider protecting all exposed wiring in attic

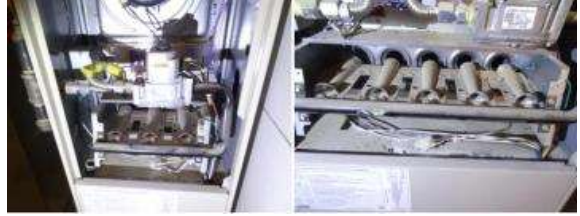
Both system are dirty but in operational condition. Suggest cleaning.

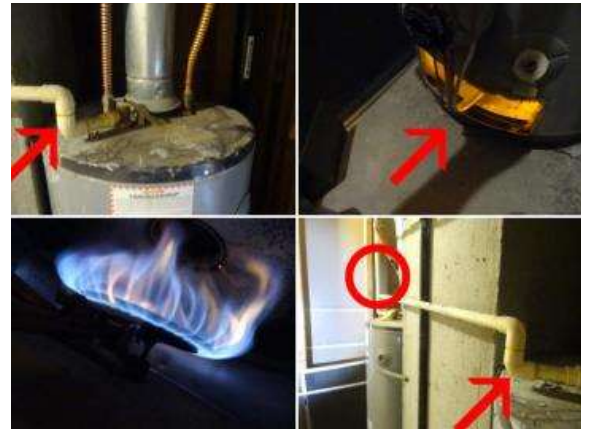
Basement, Utility.
TPR drains are not draining by gravity. While Oregon code has made several changes to its originally properly revised code disallowing draining up and out rather than by gravity only, it is preferable and safer to drain the TPR line by gravity only. (Oregon code inspectors will not take any responsibility should something not perform properly, therefore I advice you to make the changes and redirect the drain for safety)
Suggest draining tpr line to within six inches above floor in sump pump room. Code requires a pan to be installed under a water heater in any stick

framed building.
Corrections are recommended. (Drain pan to sump pump room)
A shut off valve is noted and is in serviceable condition
Vent is properly installed
Monitor Water Heater.
We expect this type of system to last about 12 to 15 years. Look for rust staining and corrosion at top and at fitting. Monitor heater for minor leaks. Replace unit if damage is noted.
