## Confidential Inspection Report 4121 NE Alameda St Portland OR 97212

December 6, 2014

A visual inspection of the above referenced property was conducted on 12/04/14. An earnest effort was made on your behalf to discover all visible defects. The following is an opinion report, reflecting the visual conditions of the property at the time of the inspection only. Hidden or concealed defects cannot be included in this report. No warranty is either expressed or implied. This report is not an insurance policy, nor a warranty service.

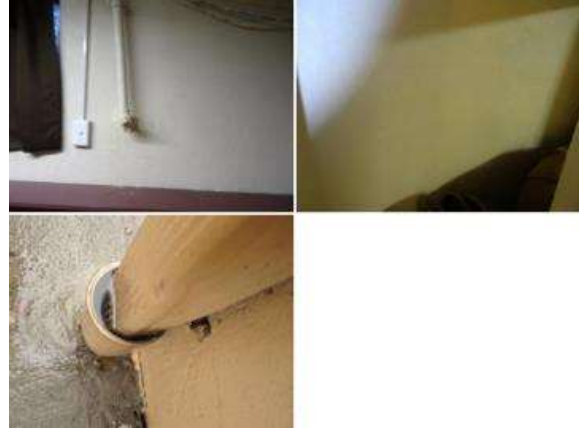
*Basement/Foundation Walls conditions:*

Foundation is serviceable and in good condition. Ensure all drainage issues at exterior are properly corrected. It is a matter of time before this will result in moisture penetration into the basement.

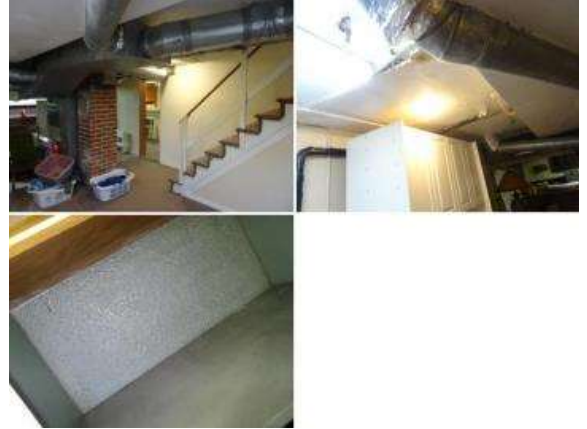
*Other Observations*

No visible defects or structural issues are noted. We do not anticipate future structural issues with any components of the substructure/basement of this building provided proper maintenance is completed regularly. Areas under cabinets appear to be wet but are actually dry.

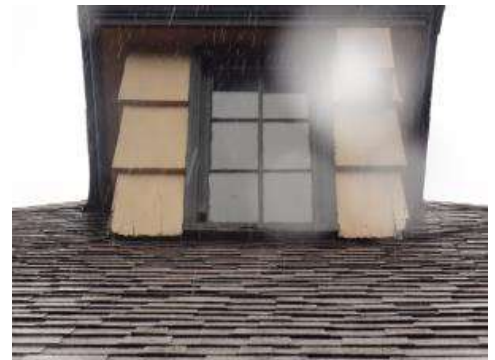
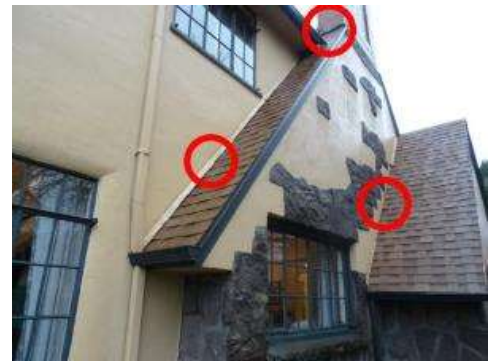
*FLASHING TYPE: and conditions* Metal, rubber and comp. Flashing is serviceable.

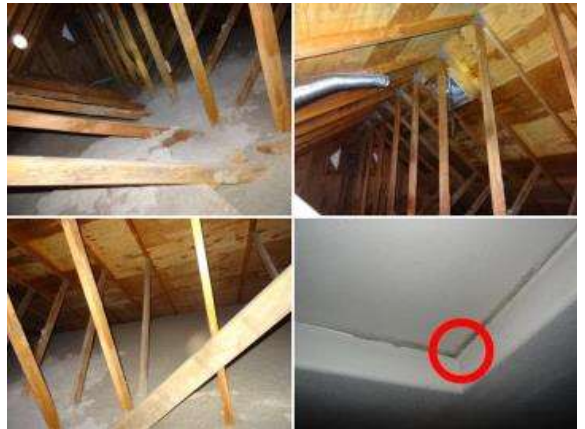
*Attic Accessibility and conditions:*

ADU: Suggest replacing mechanical vent with solar mechanical vent. Thermostatically controlled vent may be operational but a solar vent would be beneficial as it runs almost every day providing proper airflow on cold as well as on warm days.  
 Bath and kitchen vents need to be terminated to the outside. Corrections are recommended.  
 Insulation is provide.  
 Truss framing is in good condition. Mold is noted at hatch . Ensure vents are used in bathroom and kitchen.  
 Main house attic: Attic is full size. Conventional Framing.  
 Accessible. Additional venting is needed.  
 Consider installing solar powered mechanical venting.  
 This type of vent will run

every day rain or shine and promote proper ventilation at all times. In addition it will lower temperatures in living areas during summer months by ten to fifteen degrees.

Minor damage is noted at a rafter on west side at dormer. (Improper cut)

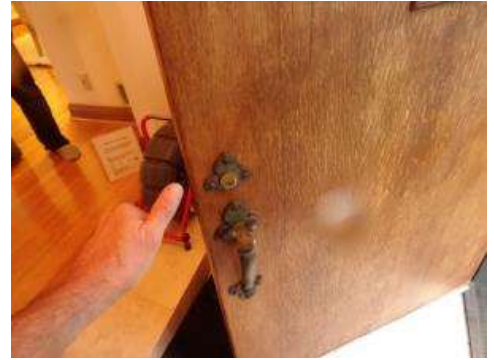
DOORS: *Main Entry Door:*

Appears to be in good condition.  
Consider re finishing door.

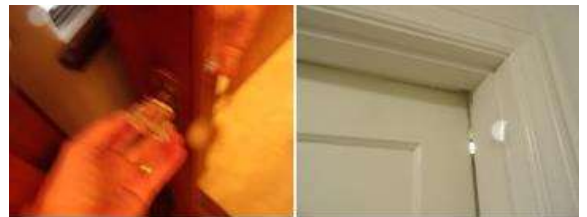
*Interior Doors:*

Serviceable  
Minor adjustments are recommended.  
(Hardware)  
Doors Rub and Stick in some areas.

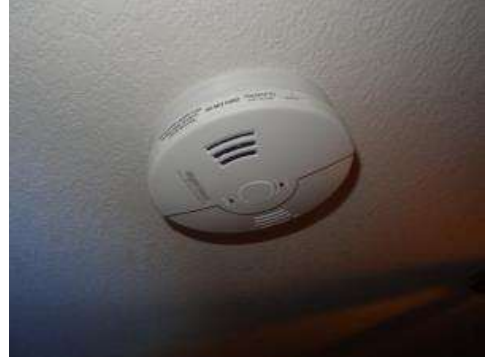
Smoke and carbon monoxide detector is noted in ADU

Carbon monoxide detectors should be installed either on ceiling (as per Code) or near floor. (plug in type) Carbon monoxide is heavier than air (Mixed with other flue gases) and will collect on floor. Installing detectors on ceiling will help if carbon monoxide is delivered via heating ducts and air is hot. Eventually it will settle near floor. Both systems should be installed for safety.

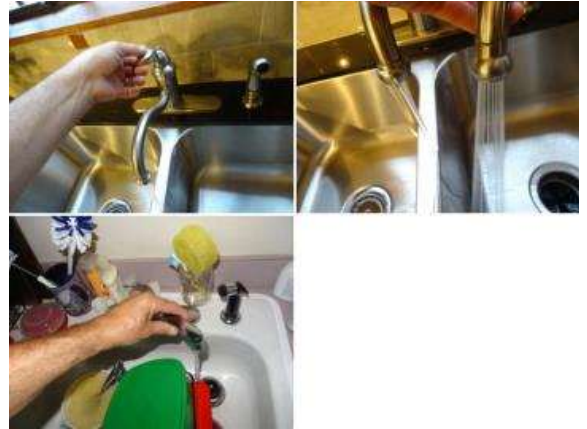
**Kitchen Sink:**

Stainless and Porcelain in ADU  
Sinks are in serviceable condition.  
Minor improvements are recommended at kitchen faucet. Spryer needs valve adjustment

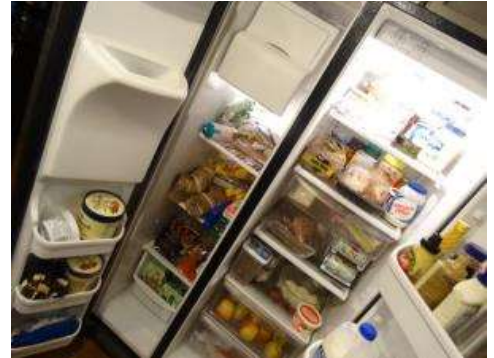
**Refrigerator And Ice Maker**

Fridge and Ice maker are serviceable  
Recommend monitoring fridge for signs of leaks at water connection  
I recommend installing electronic shut off valve that would prevent flooding should the supply line ever leak.

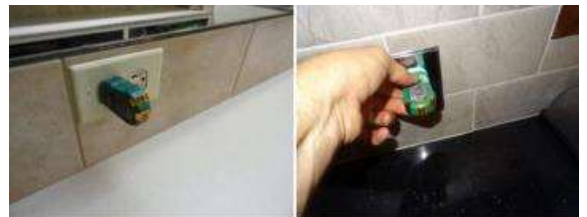
*Switches/Fixtures/Outlets and other Observations:*

Recommend installing GFCI units in all outlets of kitchen. Including at bar area in basement.

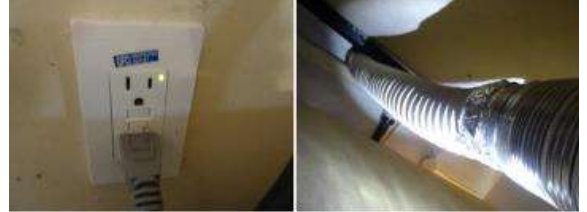
Condition: 110 is grounded and GFCI protected. 220 is provided. Recommend installing ridged metal vent for safety.

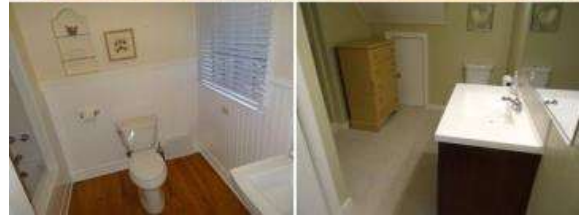
*Sink*

Appears to be serviceable. Monitor all valves for leaks in the future. Staining and damage related to old leaks are noted.

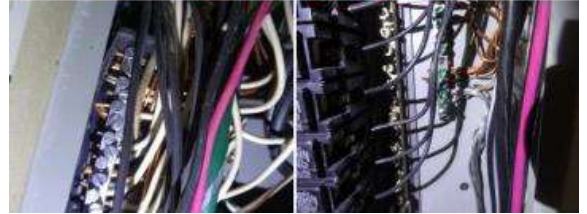
Multiple wires are installed in single lug. This is not allowed on this particular panel. Minor corrections are needed.

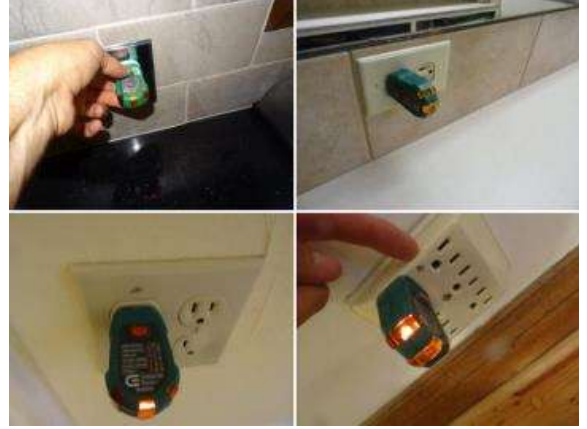
Reversed Polarity is noted and marked with flag or dot to left of outlet

Minor corrections and improvements are needed.

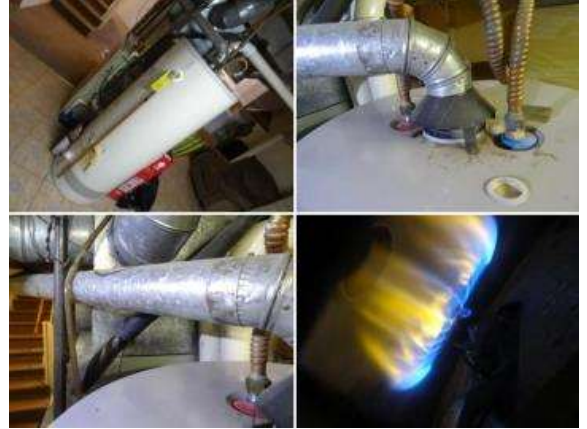
Incomplete combustion is noted to excessive condensation drip. This results in inefficient heating of the water and subsequently in added cost to utility bill.

Consider having the water heater replaced with a efficient new system.

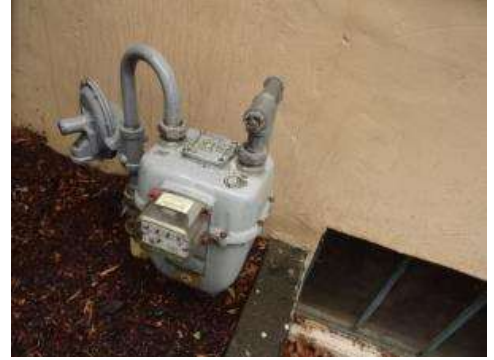
*Meter, Tank, Location and condition*

Exterior Location, System appears to be serviceable. Recommend contacting your local Utility, request a gas meter shut off wrench and install the wrench behind meter for emergency.

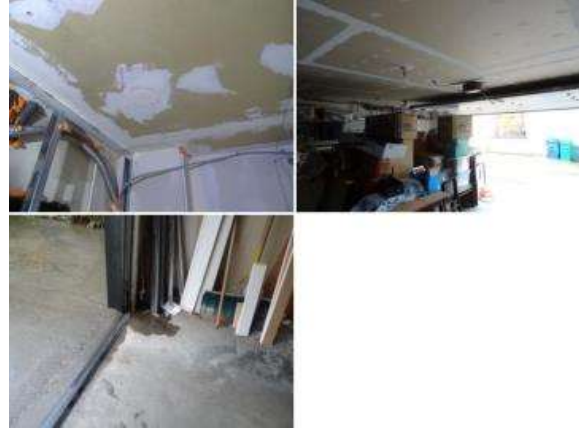
### Type:

Detached Garage is generally not a part of the home inspection. Garage has been inspected due to the ADU unit located above. Building is in solid and serviceable condition. Moisture is penetrating at both south facing corners due to improperly draining downspouts. Corrections are needed. Garage door and walls are in serviceable condition. Staining is noted at ceiling below shower area. A leak is not observed today but may be present under certain conditions. Suggest asking sellers about history and if repair had ever been completed.
