Confidential Inspection Report 01837 SW Radcliffe RD Portland OR 97219

December 27, 2014

RE: 01837 SW Radcliffe Rd Portland OR 97219

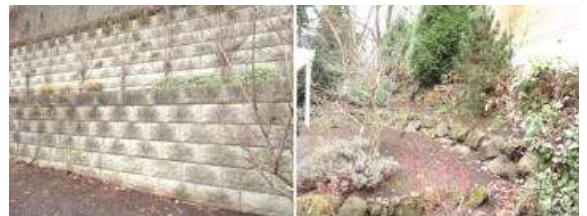
Concrete and rock walls are installed on wes side of the property. Walls are in good condition without ay signs of displacement.

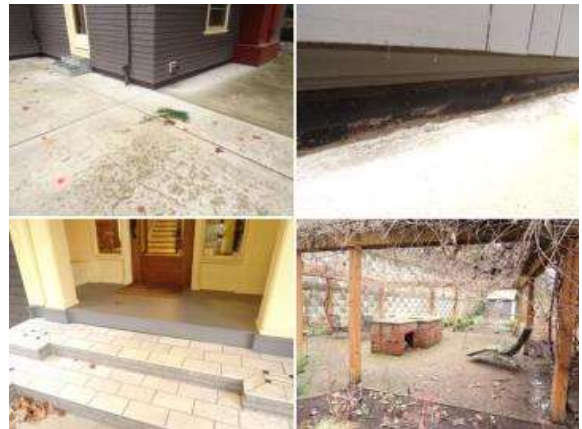
Concrete patio is installed along building. A brick patio is noted in backyard.
 Concrete patio appears to be flashed properly at foundation. No signs of moisture penetration are noted inside basement.
 Patio is slopping away from building allowing for proper drainage.
 Front porch is tied into this patio and is in good condition.

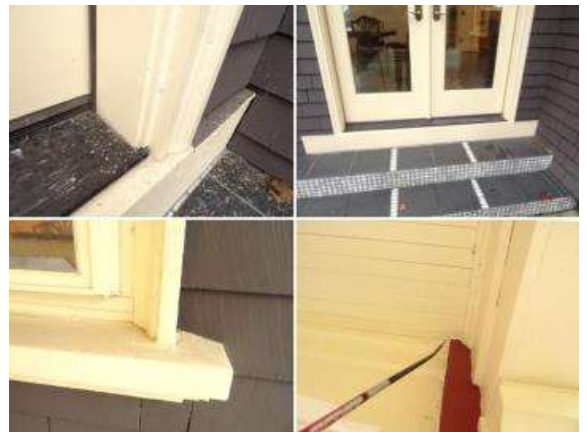
Some repairs are noted at porch overhangs. Repairs appear to be properly completed.

Ensure annual inspections are conducted and touch up, caulking and repairs are completed as needed.

Monitor all door trim for signs of early deterioration. Paint on newer wood will need to be maintained in very

good condition as this type of lumber tends to deteriorate faster than old growth lumber. Monitor and make improvements as needed

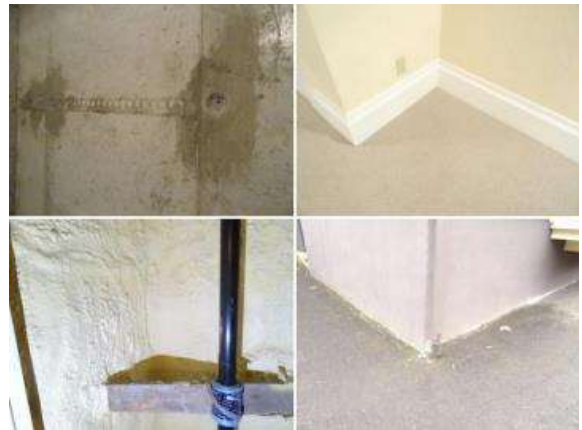
Visible areas of foundation are in good condition. Spray insulation is noted in several areas. Walls and trim are inspected for any signs of moisture damage or staining. Neither is noted during this inspection today.

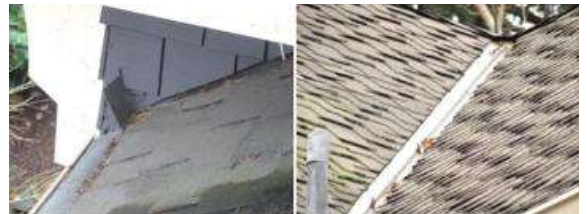
Metal, rubber and comp Flashing is serviceable.

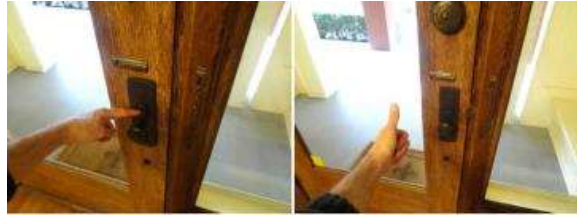
Appears to be in good condition. Suggest minor hardware adjustments.

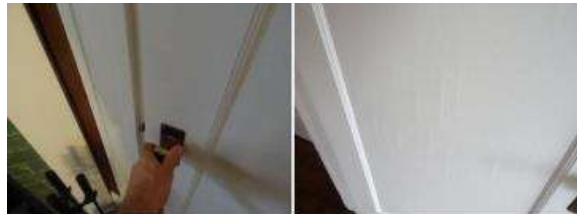
Mostly serviceable. Some closet doors are not shutting properly. Minor delamination is noted on some doors.

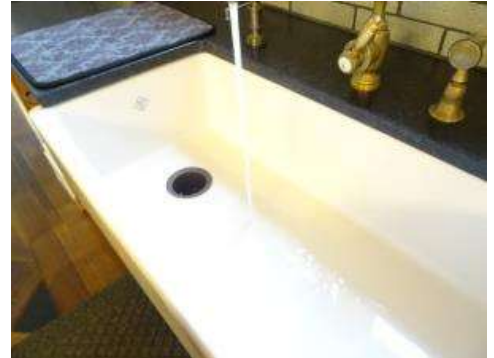
Porcelain.
Appears to be in serviceable condition
Monitor all plumbing related systems under sink for signs of leaks in the future and make repairs as needed.

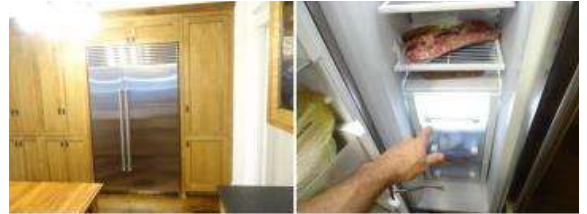
Fridge and Ice maker are serviceable
I recommend installing electronic shut off valve that would prevent flooding should the supply line ever leak.

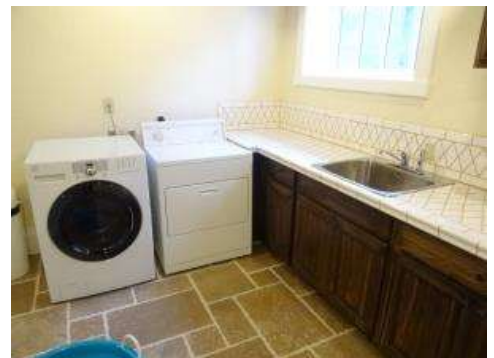
110 is grounded. GFCI protected outlet is suggested at washing machine outlet.
220 is provided. Vent is provided. Recommend installing ridged metal vent for safety
Recommend installing pan under washing machine with plumbing draining to safe location at exterior of building or into plumbing drain. (Insure a trap is installed if plumbed into drain)

Recommend installing pan under washing machine with plumbing draining to safe location at exterior of building or into plumbing drain. (Insure a trap is installed if plumbed into drain)

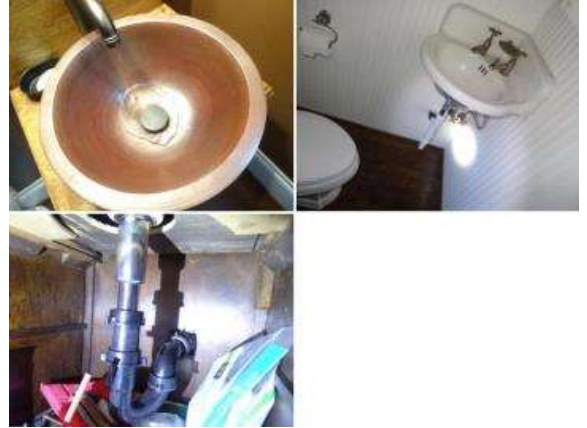
All sinks are operational. Several sink do not have an overflow! Caution is recommended.

Monitor all sink drains, valves and supply lines for ay future leaks and make repairs as needed. Several sinks do not have access to shut off valves.

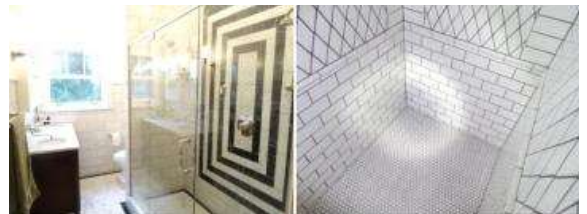
Appears to be serviceable
Maintain caulking in good condition
Recommend using tile and grout cleaner sealer on a regular basis to prevent early deterioration.

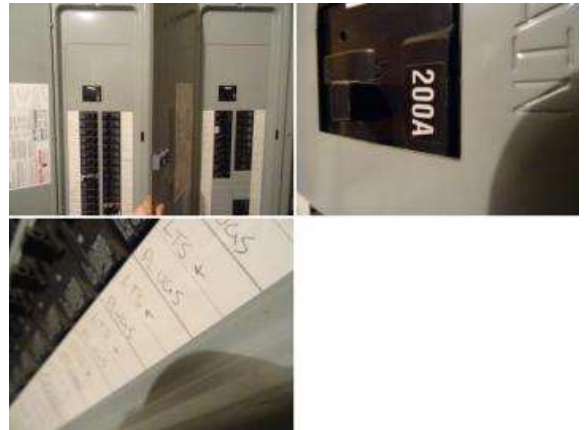
Basement. Two main
panels are installed and
servicing the home
Appears serviceable.
Panels are labeled.
200 amp service.

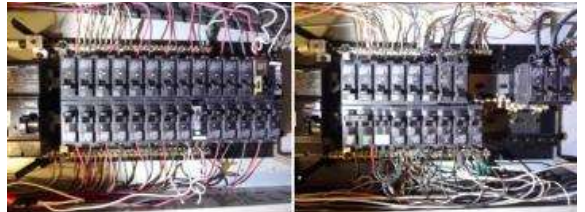
Circuit and wire sizing correct so far a visible. Grounding system is noted and appears to be serviceable. Bond is noted. Wiring above panel is unprotected. Corrections are recommended.

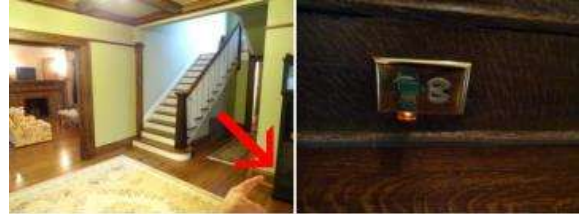
Reversed polarity outlet is noted in entrance of building at north wall to right of stairs. Minor corrections are suggested

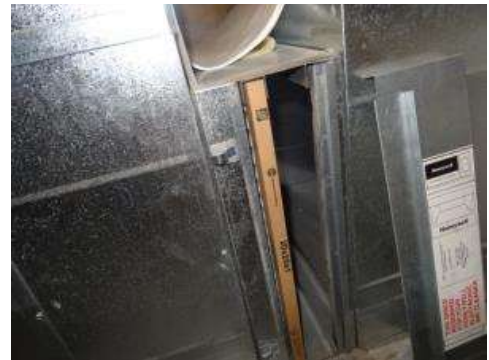
Filters are installed and is serviceable. Filters should be changed every 30 to 45 days, depending on conditions. Consider minor alterations so a high efficiency box filter can be installed on the system. High efficiency filters need to be changed only once every year.

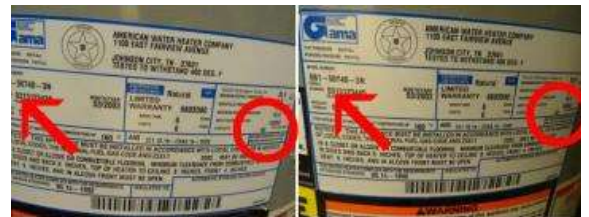
Two gas water heaters are installed.
50 Systems are 11 years old.

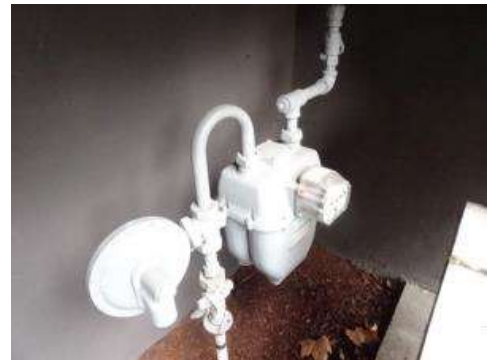
Meter, Tank, Location and condition

Exterior Location, System appears to be serviceable. Recommend contacting your local Utility, request a gas meter shut off wrench and install the wrench behind meter for emergency.
